Contract #: 04-0120F4Cty: SF/ALA Rte: 80 PM: 13.2/13.9File #: 99.28**WELDING INSPECTION REPORT****Resident Engineer:**Siegenthaler, Peter**Address:** 333 Burma Road**City:** Oakland, CA 94607**Report No:** WIR-019397**Date Inspected:** 20-Jan-2011**Project Name:** SAS Superstructure**OSM Arrival Time:** 700**Prime Contractor:** American Bridge/Fluor Enterprises, a JV**OSM Departure Time:** 1900**Contractor:** Zhenhua Port Machinery Company, Ltd (ZPMC)**Location:** Shanghai, China**CWI Name:** Li Yang and Zhu Zhong Hai**CWI Present:** Yes No**Inspected CWI report:** Yes No N/A**Rod Oven in Use:** Yes No N/A**Electrode to specification:** Yes No N/A**Weld Procedures Followed:** Yes No N/A**Qualified Welders:** Yes No N/A**Verified Joint Fit-up:** Yes No N/A**Approved Drawings:** Yes No N/A**Approved WPS:** Yes No N/A**Delayed / Cancelled:** Yes No N/A**Bridge No:** 34-0006**Component:** OBG Trial Assembly**Summary of Items Observed:**

Orthotropic Box Girder (OBG) at Trial Assembly Areas

Segment 12BW to Segment 12CW (T- Rib Splice weld)

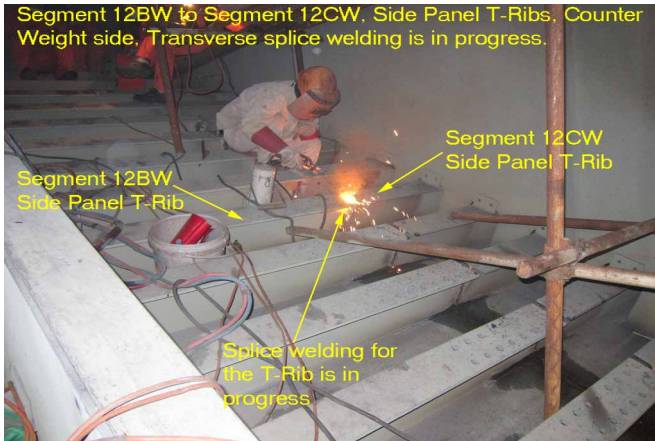
This QA Inspector observed the in-process welding by Shielded Metal Arc Welding (SMAW) process on a Complete Joint Penetration (CJP) groove weld. The Weld joint was designated as SP3041-001-042. The welder identification was 040611 and observed welding in the 4G (Overhead) position using approved Welding Procedure Specification WPS-B-P-2214-B-U2-FCM-1. The piece mark was identified as the Side Panel, T-Ribs at transverse splice, Cross Beam side.

This QA Inspector observed the in-process welding by Shielded Metal Arc Welding (SMAW) process on a Complete Joint Penetration (CJP) groove weld. The Weld joint was designated as SP3050-001-042. The welder identification was 046709 and observed welding in the 3G (Vertical) position using approved Welding Procedure Specification WPS-B-P-2213-B-U2-FCM-1. The piece mark was identified as the Side Panel, T-Ribs at transverse

This QA Inspector observed the in-process welding by Shielded Metal Arc Welding (SMAW) process on a Complete Joint Penetration (CJP) groove weld. The Weld joint was designated as SP3040-001-037. The welder identification was 057333 and observed welding in the 4G (Overhead) position using approved Welding Procedure Specification WPS-B-P-2214-B-U2-FCM-1. The piece mark was identified as the Side Panel, I-Ribs at transverse splice, Cross Beam side.

This QA Inspector observed the in-process welding by Shielded Metal Arc Welding (SMAW) process on a Complete Joint Penetration (CJP) groove weld. The Weld joint was designated as SP3039-001-043. The welder identification was 041713 and observed welding in the 4G (Overhead) position using approved Welding Procedure Specification WPS-B-P-2214-B-U2-FCM-1. The piece mark was identified as the Side Panel, I-Ribs at transverse splice, Counter Weight side.

This QA Inspector observed the in-process welding by Shielded Metal Arc Welding (SMAW) process on a Complete Joint Penetration (CJP) groove weld. The Weld joint was designated as SP3051-001-040. The welder identification was 046709 and observed welding in the 4G (Overhead) position using approved Welding Procedure Specification WPS-B-P-2214-B-U2-FCM-1. The piece mark was identified as the Side Panel, T-Ribs at transverse splice, Counter Weight side.

Please reference the pictures attached for more comprehensive details.
